# LHB COACHING STOCK

## ENROUTE TROUBLE SHOOTING

R.Venkatachari  
Sr.Lecturer/C&W  
STC/SC

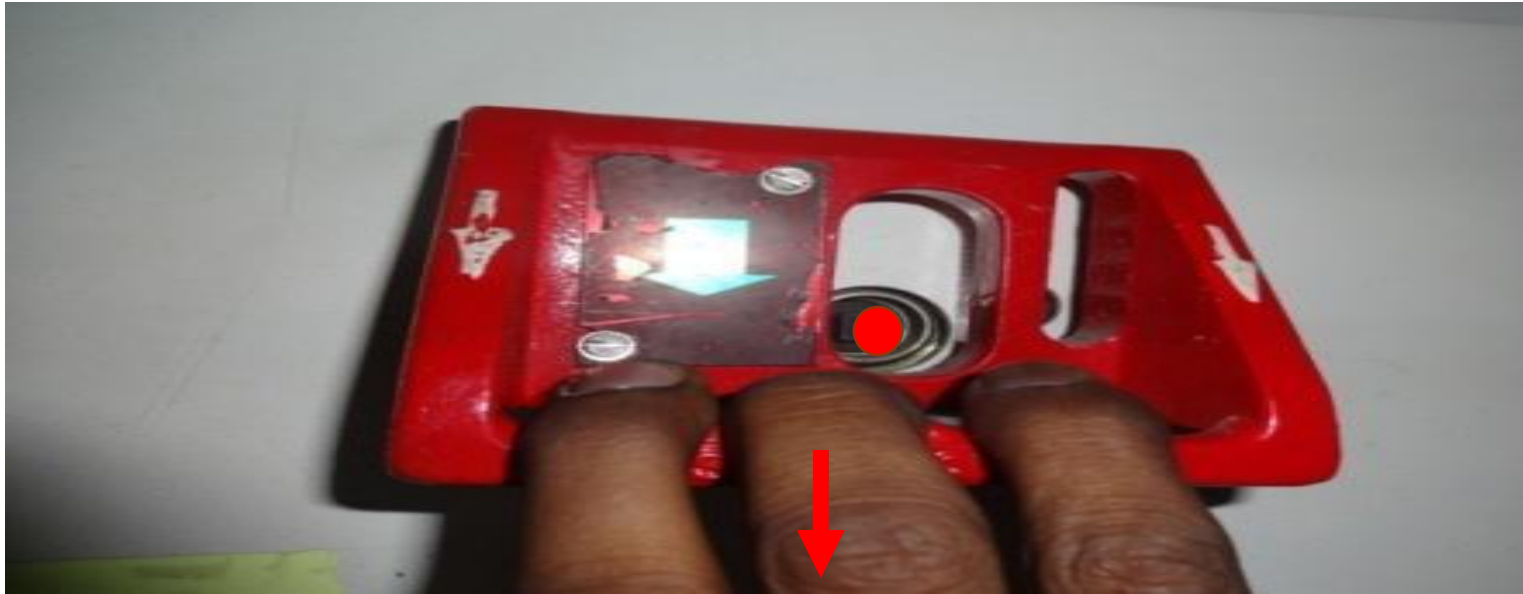
To stop the train, pull the PEASD handle down wards inside the cabin. After ACP, red light (LED) glows and BP pressure starts venting through 19 mm choke of PEAV, Emergency Brake Accelerator also activates and cause emergency brake application.

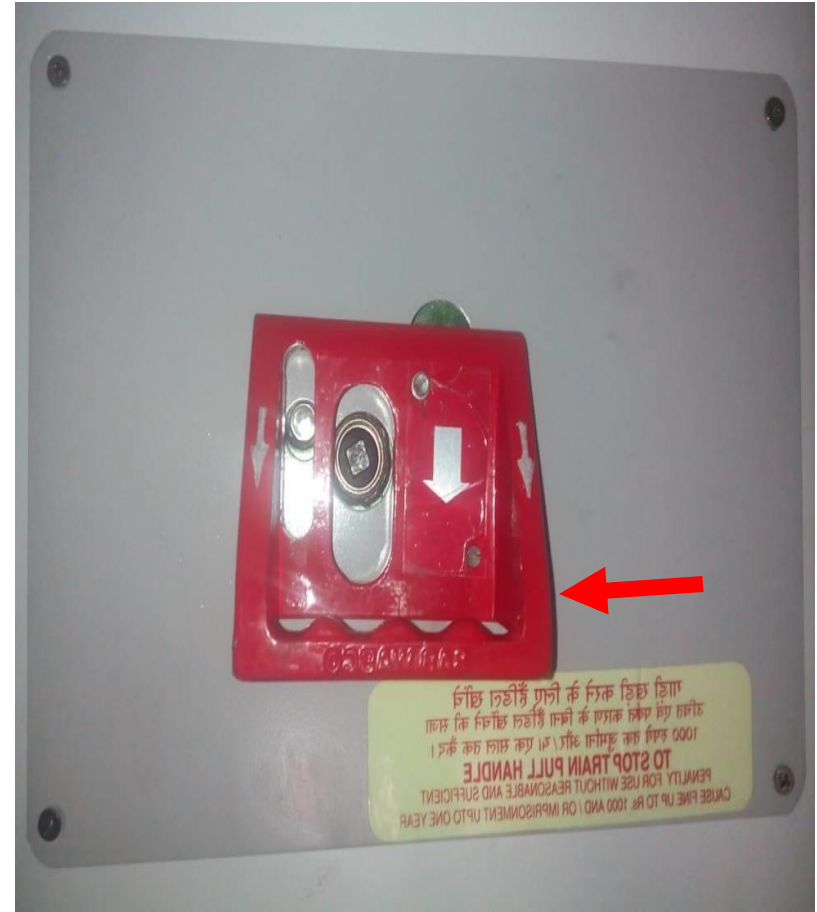
**Pulled Position**

Simultaneously the red light provided out side the coach also glows after ACP.

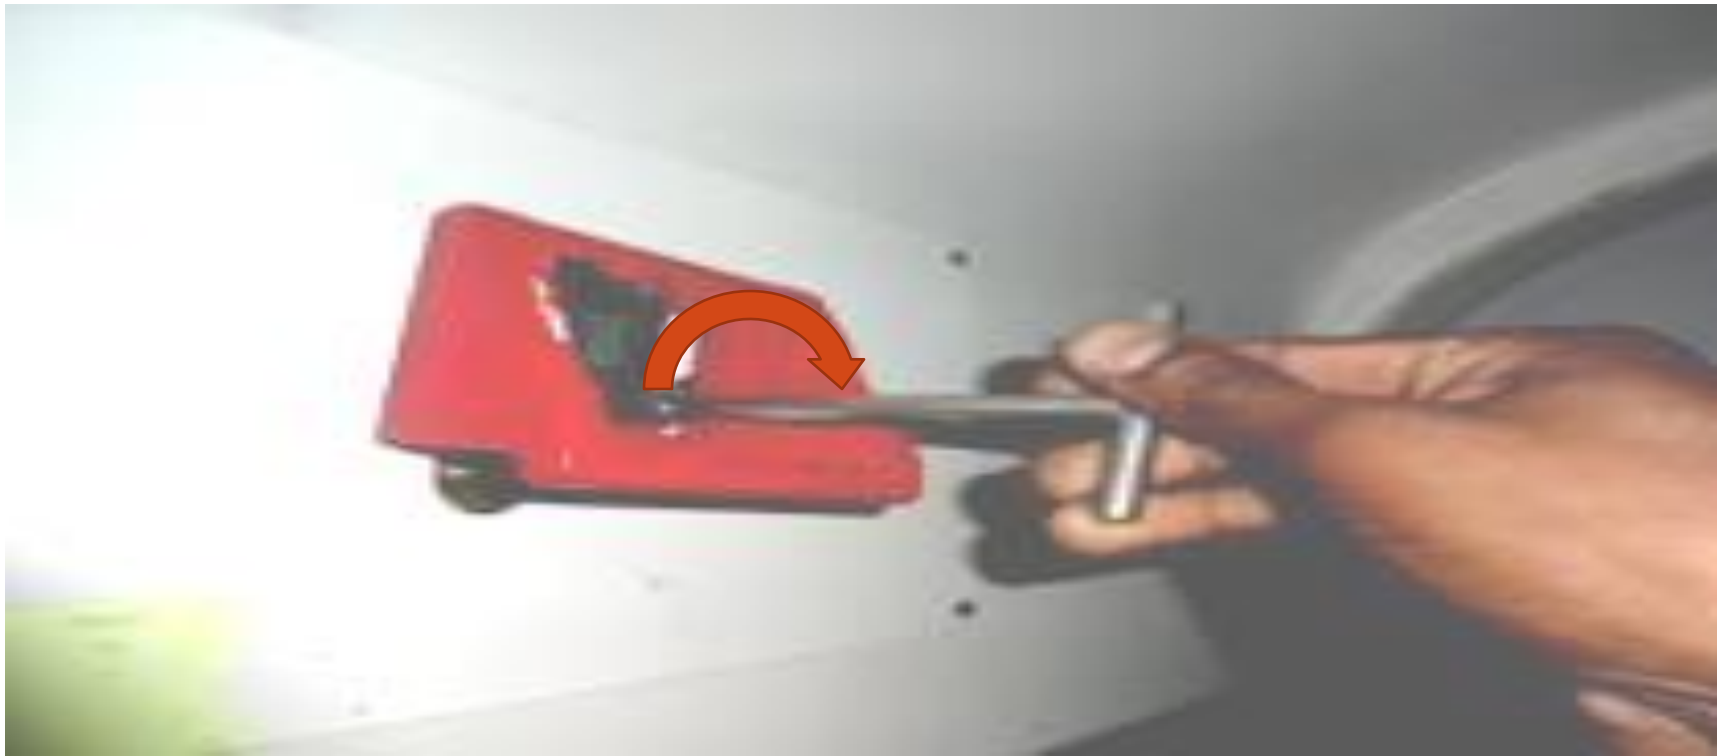
For re-setting the PEASD, insert resetting key in the PEASD and rotate in clock wise direction.

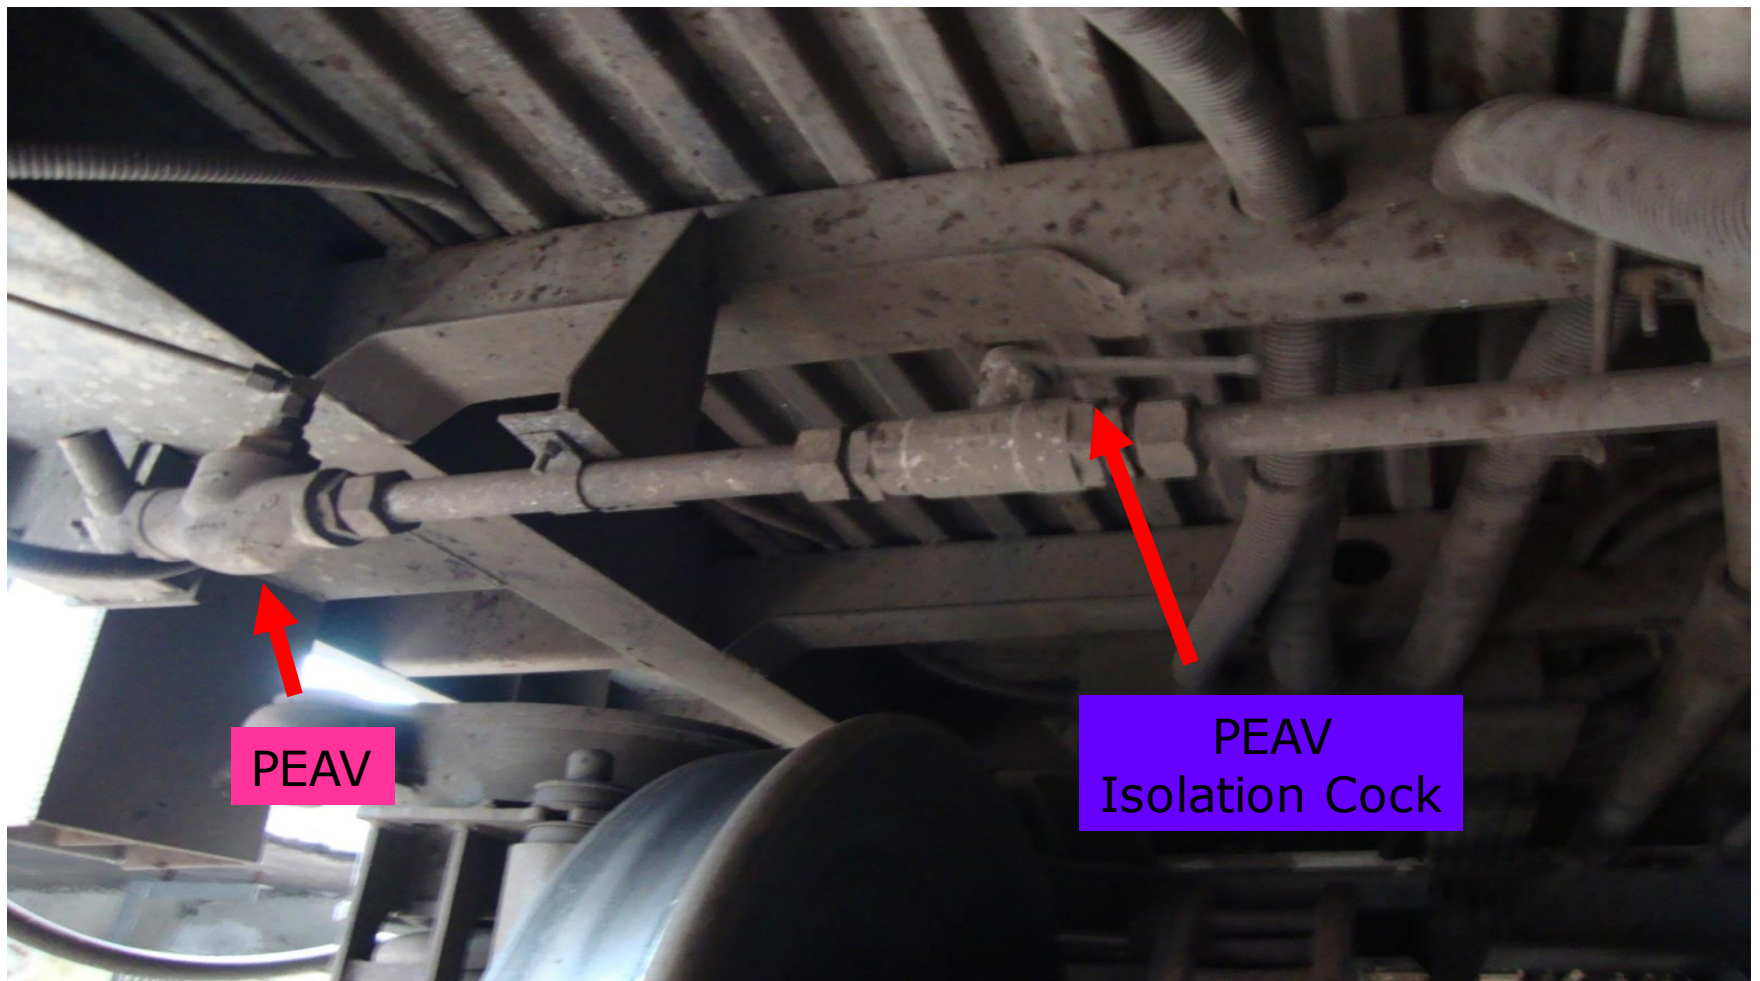
PEAV

PEAV  
Isolation Cock

If BP air leakage does not stop even after resetting, then close the PEAV isolation cock provided under the coach.

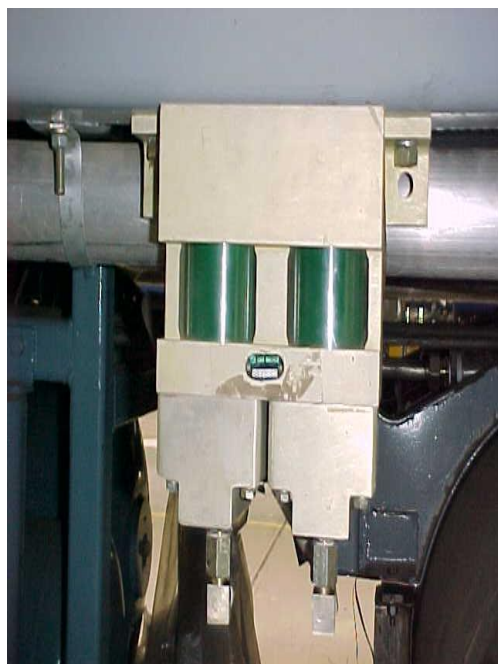
**LHB COACH**

Check Brake Indicators provided on coach side body. If Brakes in binding, Indicators will show Red.

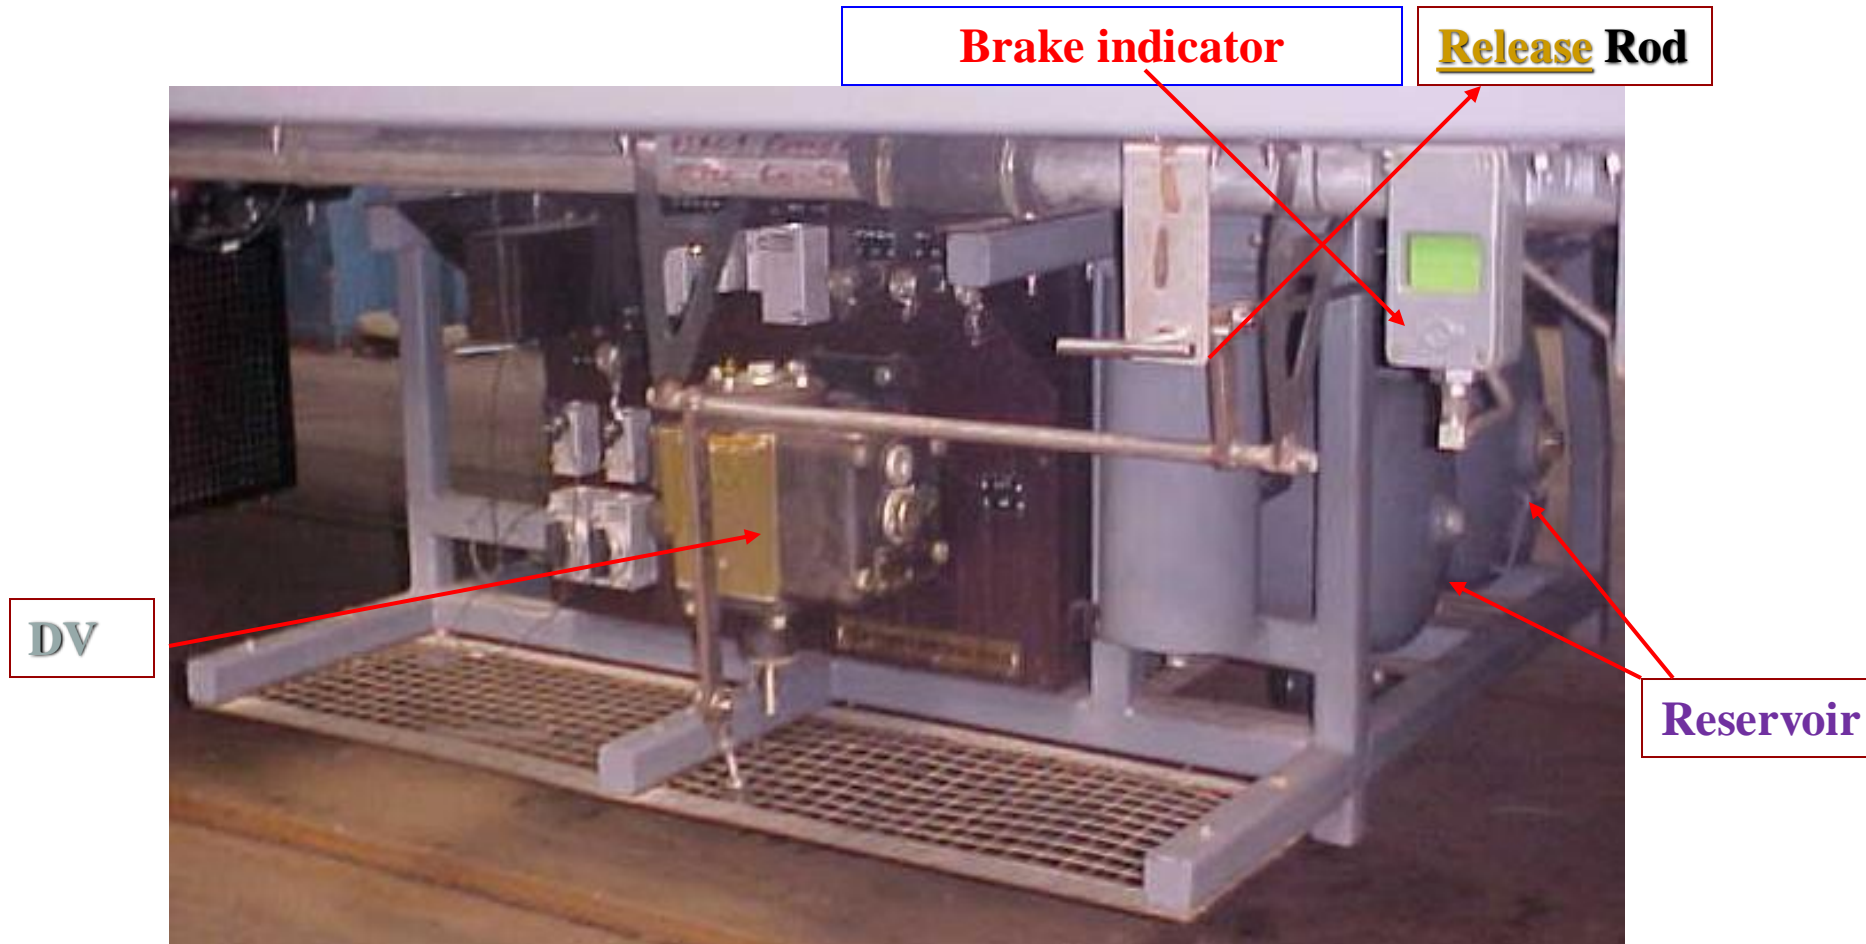
**KNORR BRAKE CONTROL PANEL AND INDICATOR UNIT**

Step-1: Pull Quick release rod / Wire of DV.

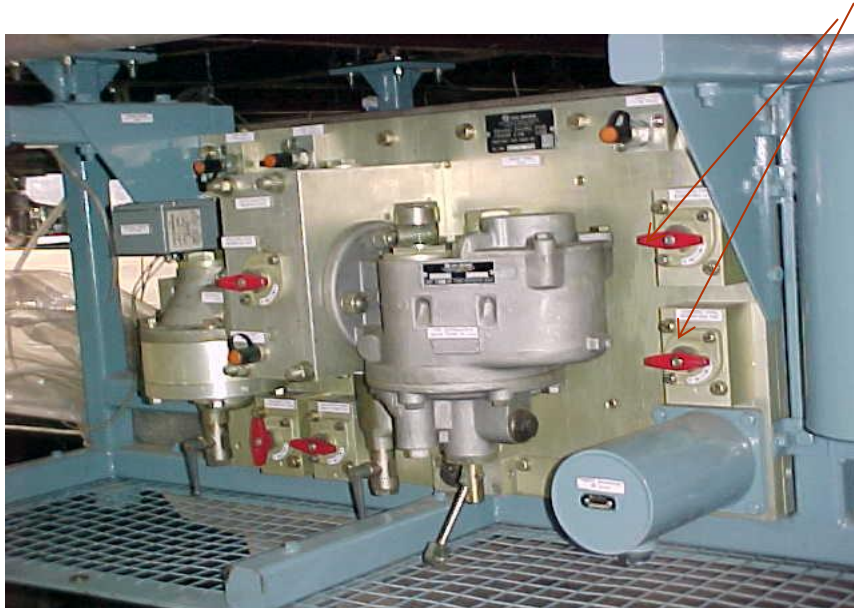
FTRIL CONTROL PANEL

**Step-2:** Close the BC Isolation Cocks (switches) of one or both the trolleys having brake binding provided in the Brake control panel.

(Rotate anticlockwise to Horizontal position)

Orientation: Vertical – Working condition

Horizontal – Isolation condition

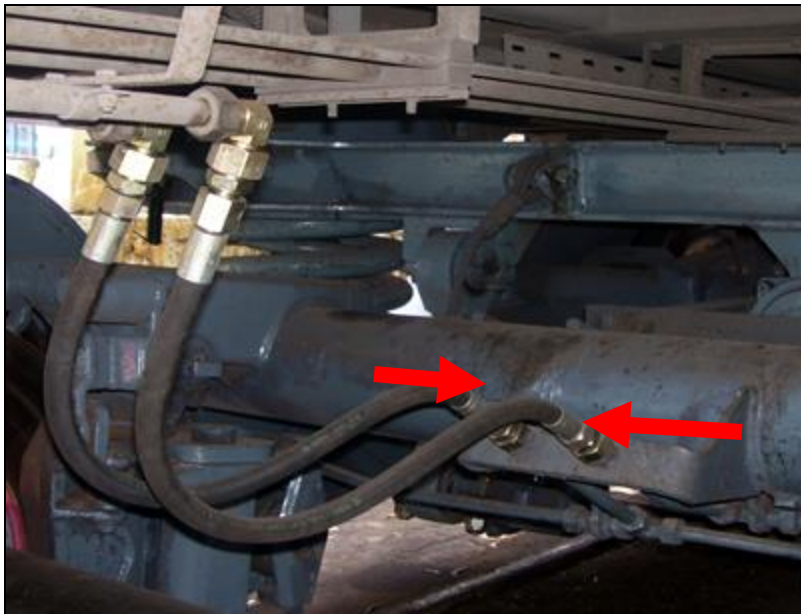
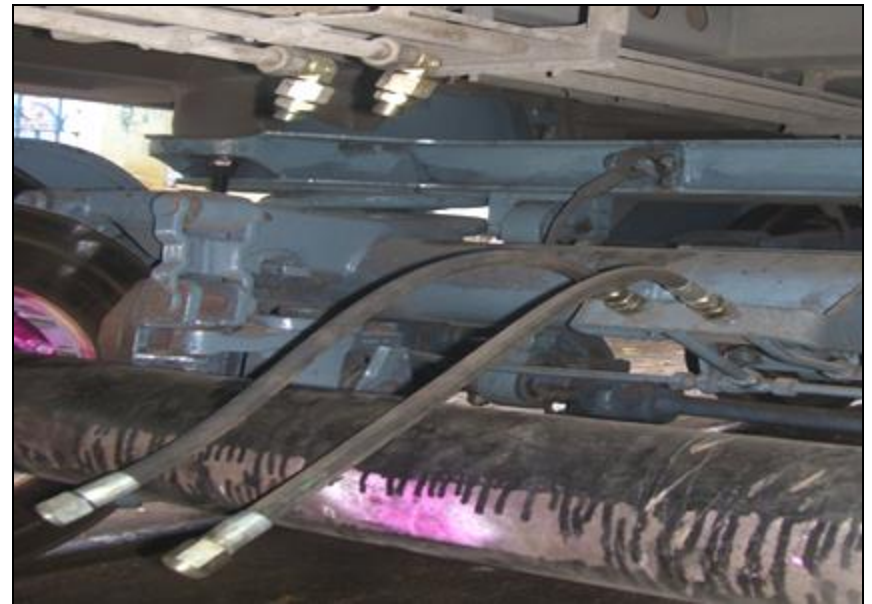
If not free, loosen the 27mm nut of BC to get Brake pad gap.

**Rotate clockwise to slack Brake pads**

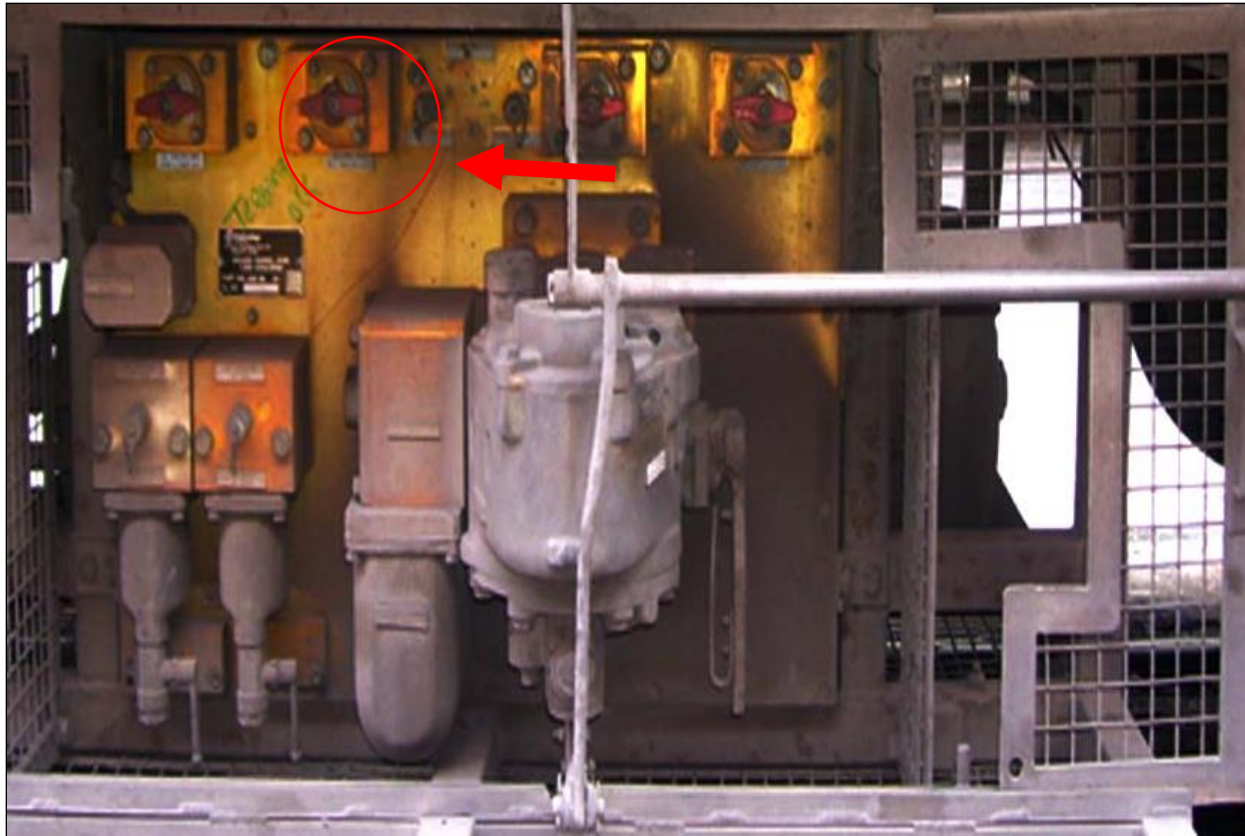
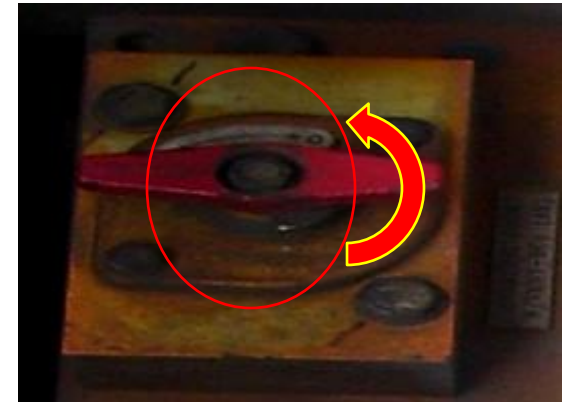
**Step-4a:** Isolate FP cock (switch) fitted in Brake panel.  
Rotate anticlockwise to **Horizontal position**.

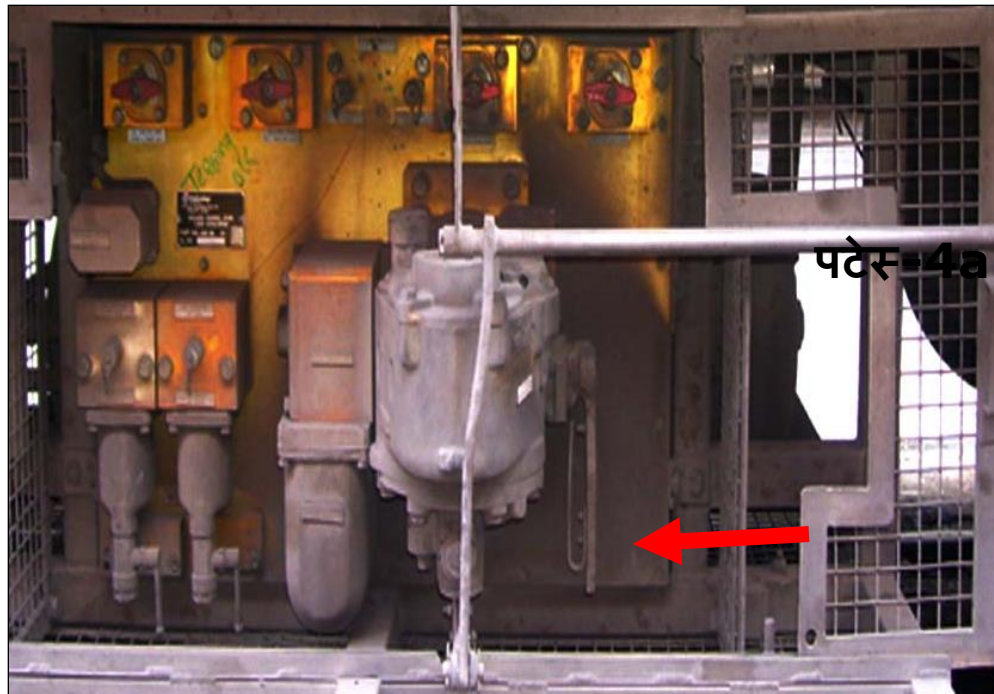
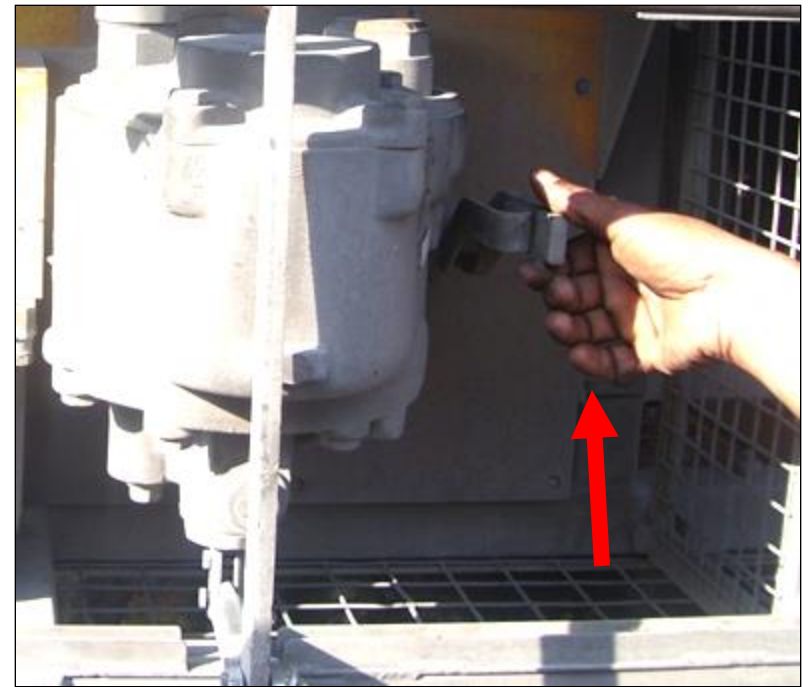
**Step-4b:** Isolate DV by lifting R-Charger Isolation handle from vertical to **Horizontal position**.

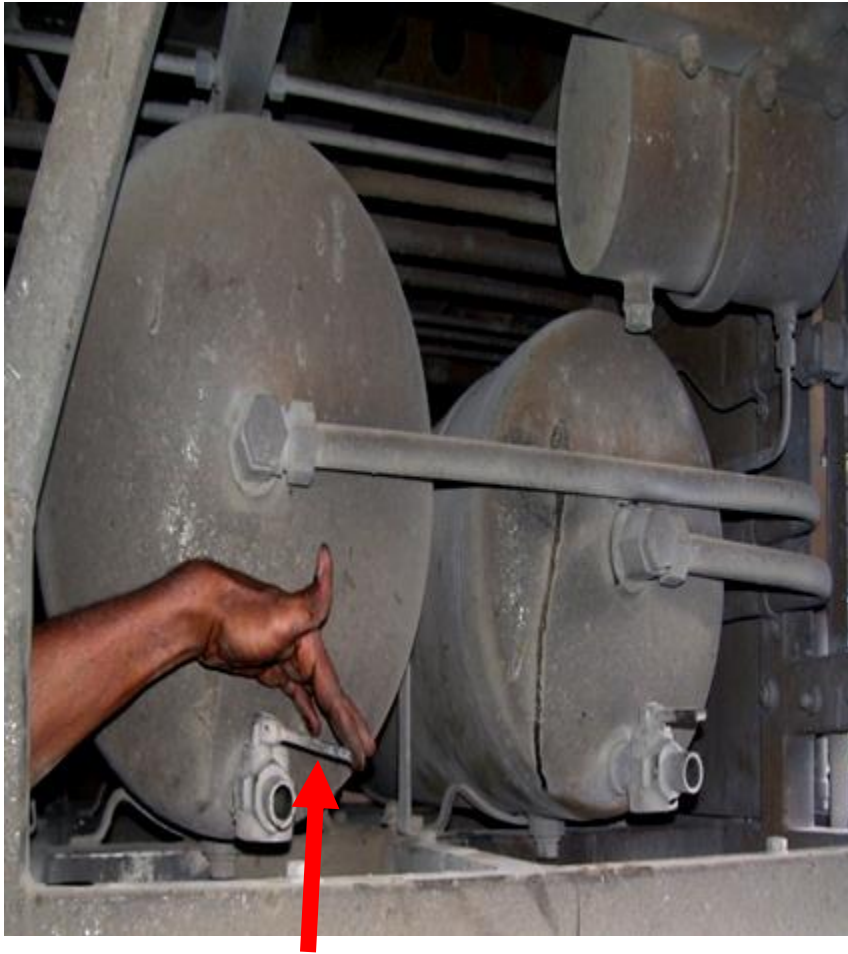
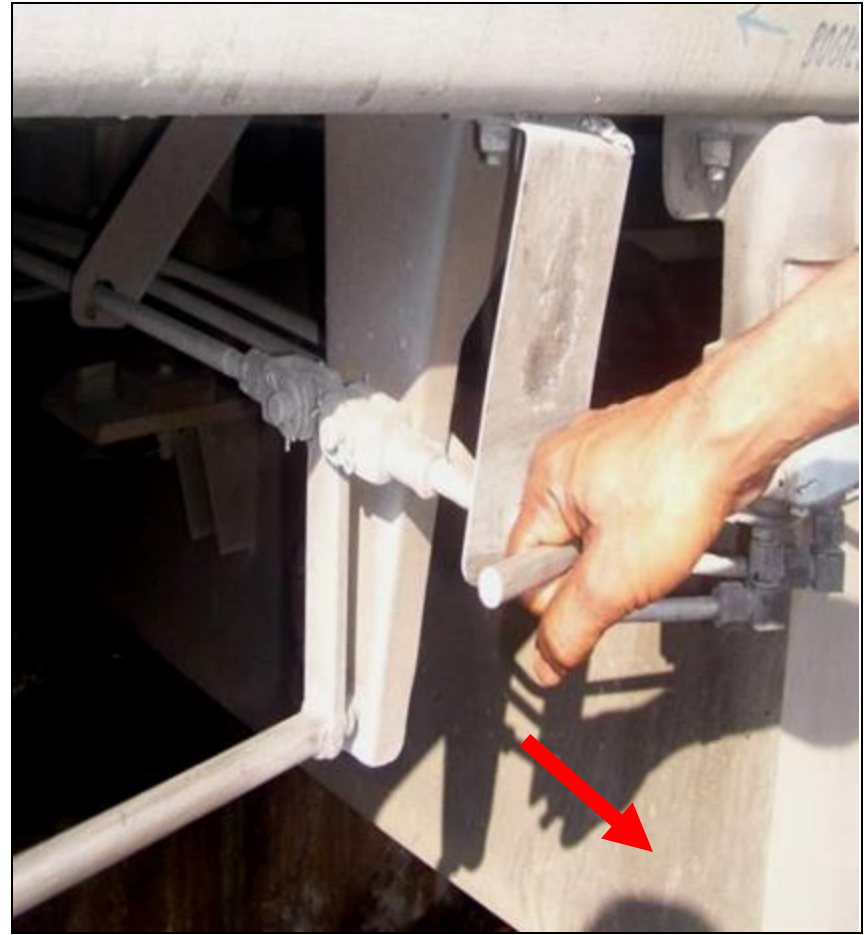
**Step-4d:** Drain out AR fully.  
Pull Quick release wire of DV to empty CR.

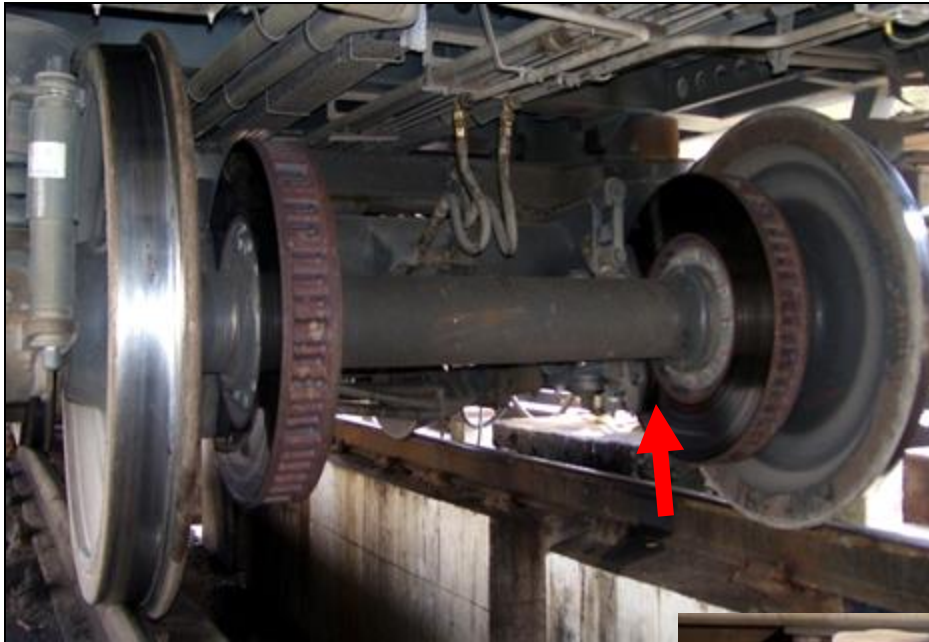
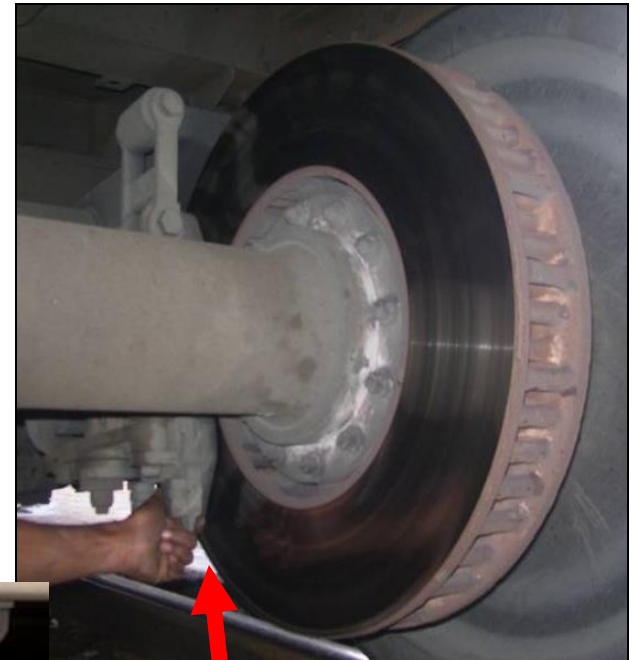
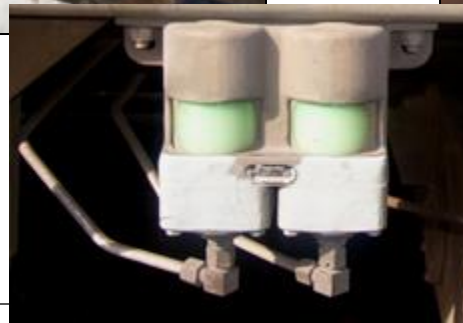
**Step - 4e:** Physically ensure the release of Brake Pads of all wheels by shaking & ensure Brake indicators in green colour.

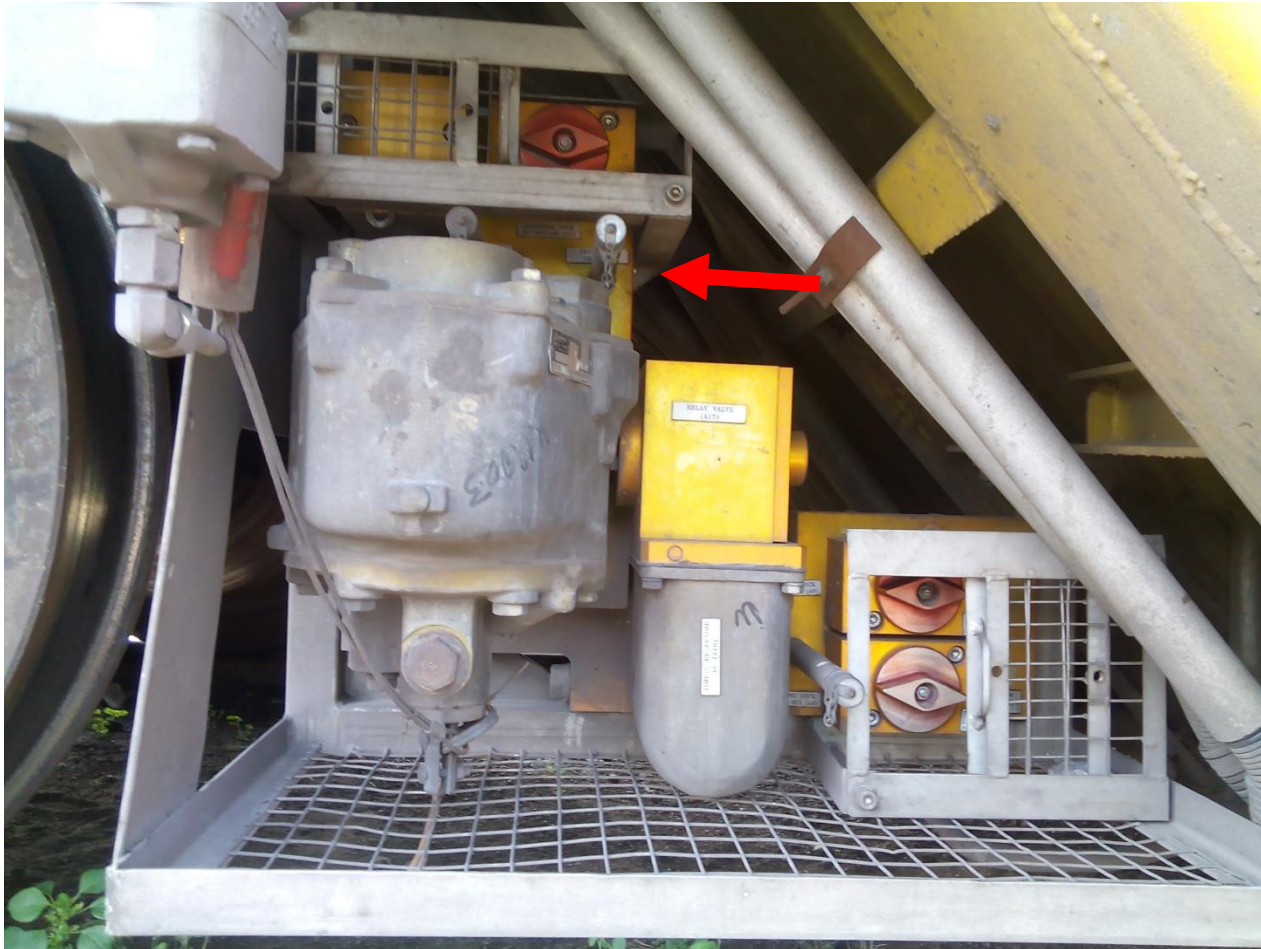
**For C3W DV there is no DV isolating handle for isolation.  
The isolation cock above the DV to be turned vertical**

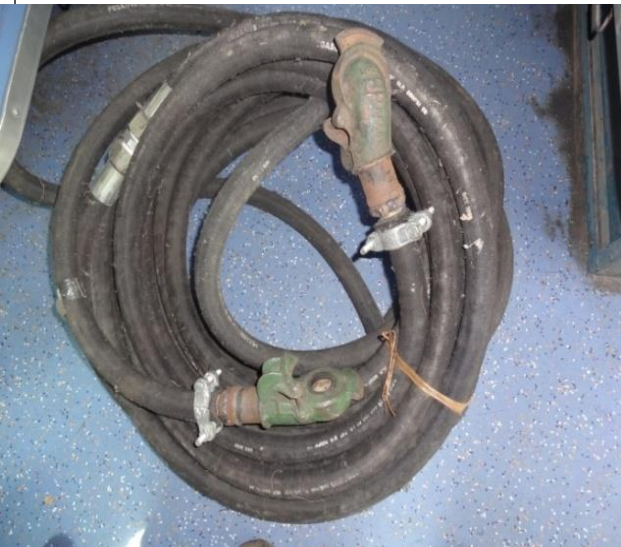
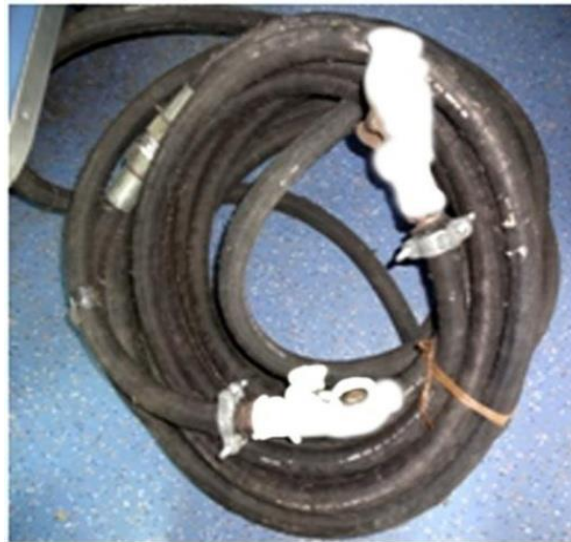
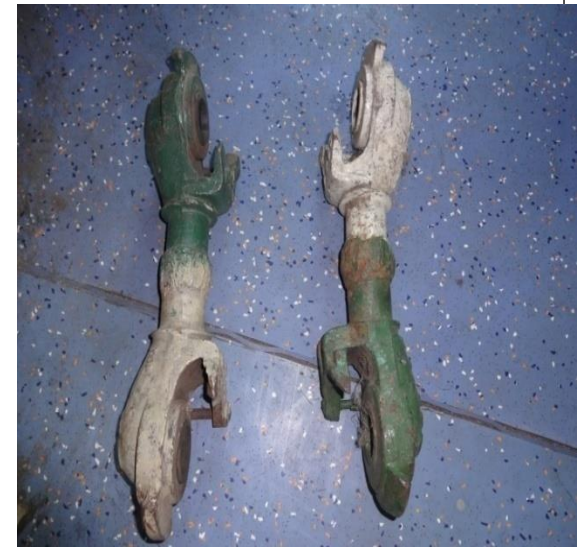
**BP by-pass Pipe (Coach length) FP by-pass Pipe (Coach length) BP/FP palm end Coupler**

**For by-passing, use coach length flexible pipe (length approx. 28m) and for converting BP flexible pipe to FP or FP flexible pipe to BP..**

**use BP/FP palm end couplers.**

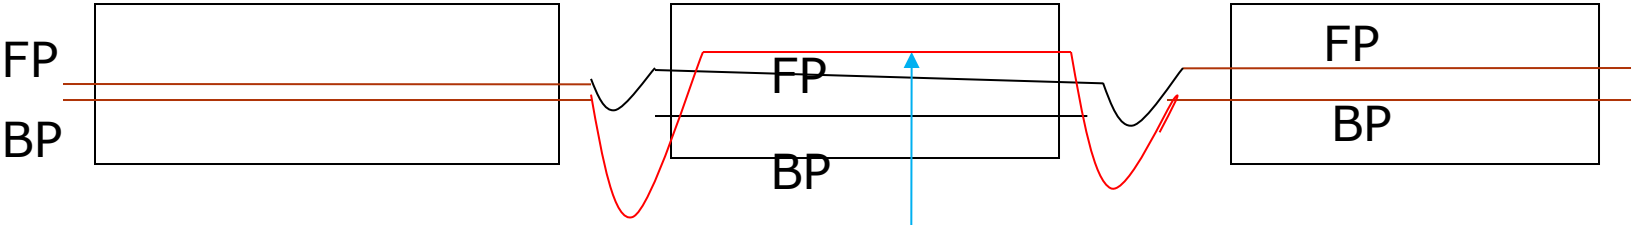
Coach length flexible pipe

Front potion

**Effected Coach**

Rear potion

- Close BP/FP cut off angle cocks on both ends of the affected coach.
- Close BP/FP cut off angle cocks of both the adjacent coaches.
- Un couple BP/FP air hoses between affected coach and adjacent coaches.
- Run coach length BP / FP by-pass flexible pipe inside the affected coach and tied properly.
- Connect coach length BP / FP by-pass flexible pipe to both the adjacent coaches and open BP/FP cut off angle cocks.

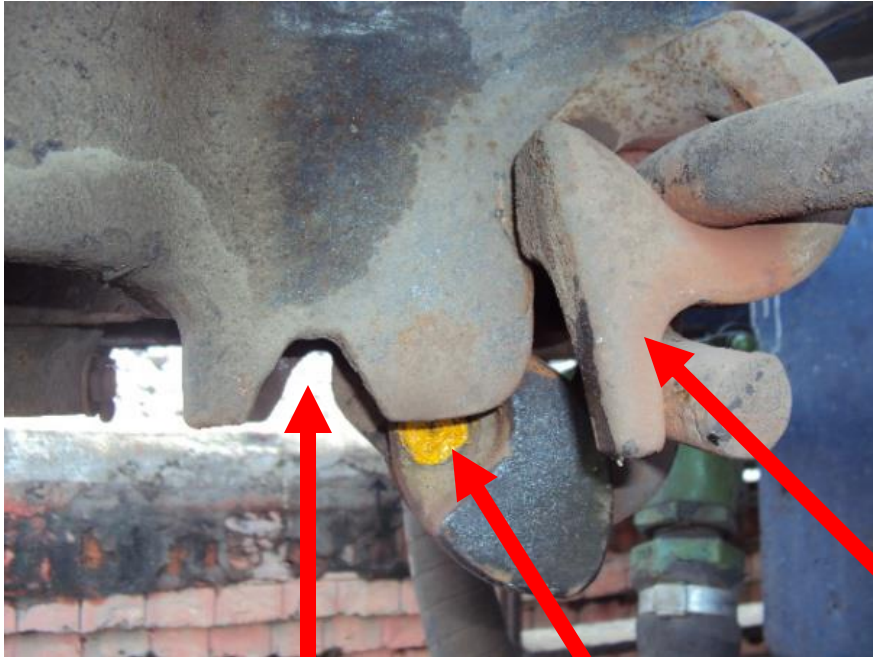
Lock lift Lever & rivet  
(Yellow mark) fully visible

Tell Tale slot (inverted 'V') is clear

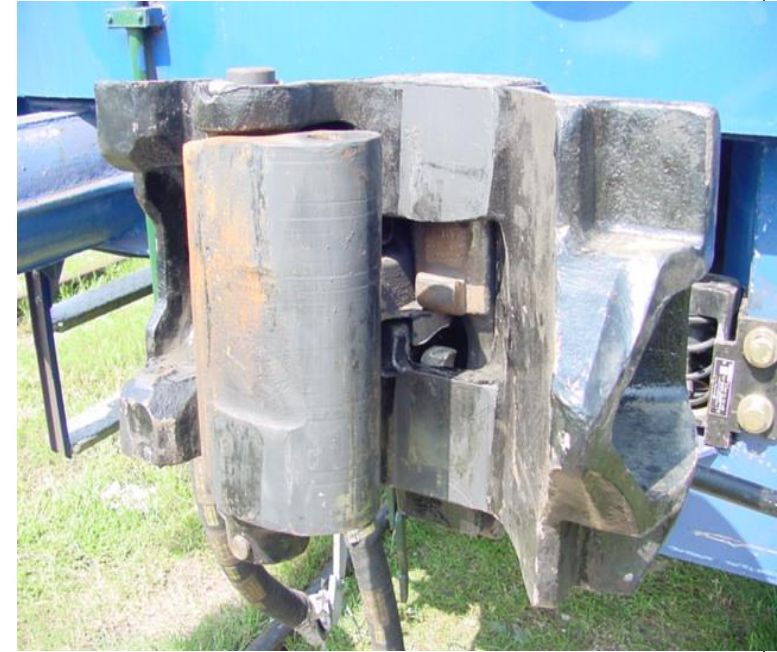
Rotary Lock Lifter rib  
vertical downwards

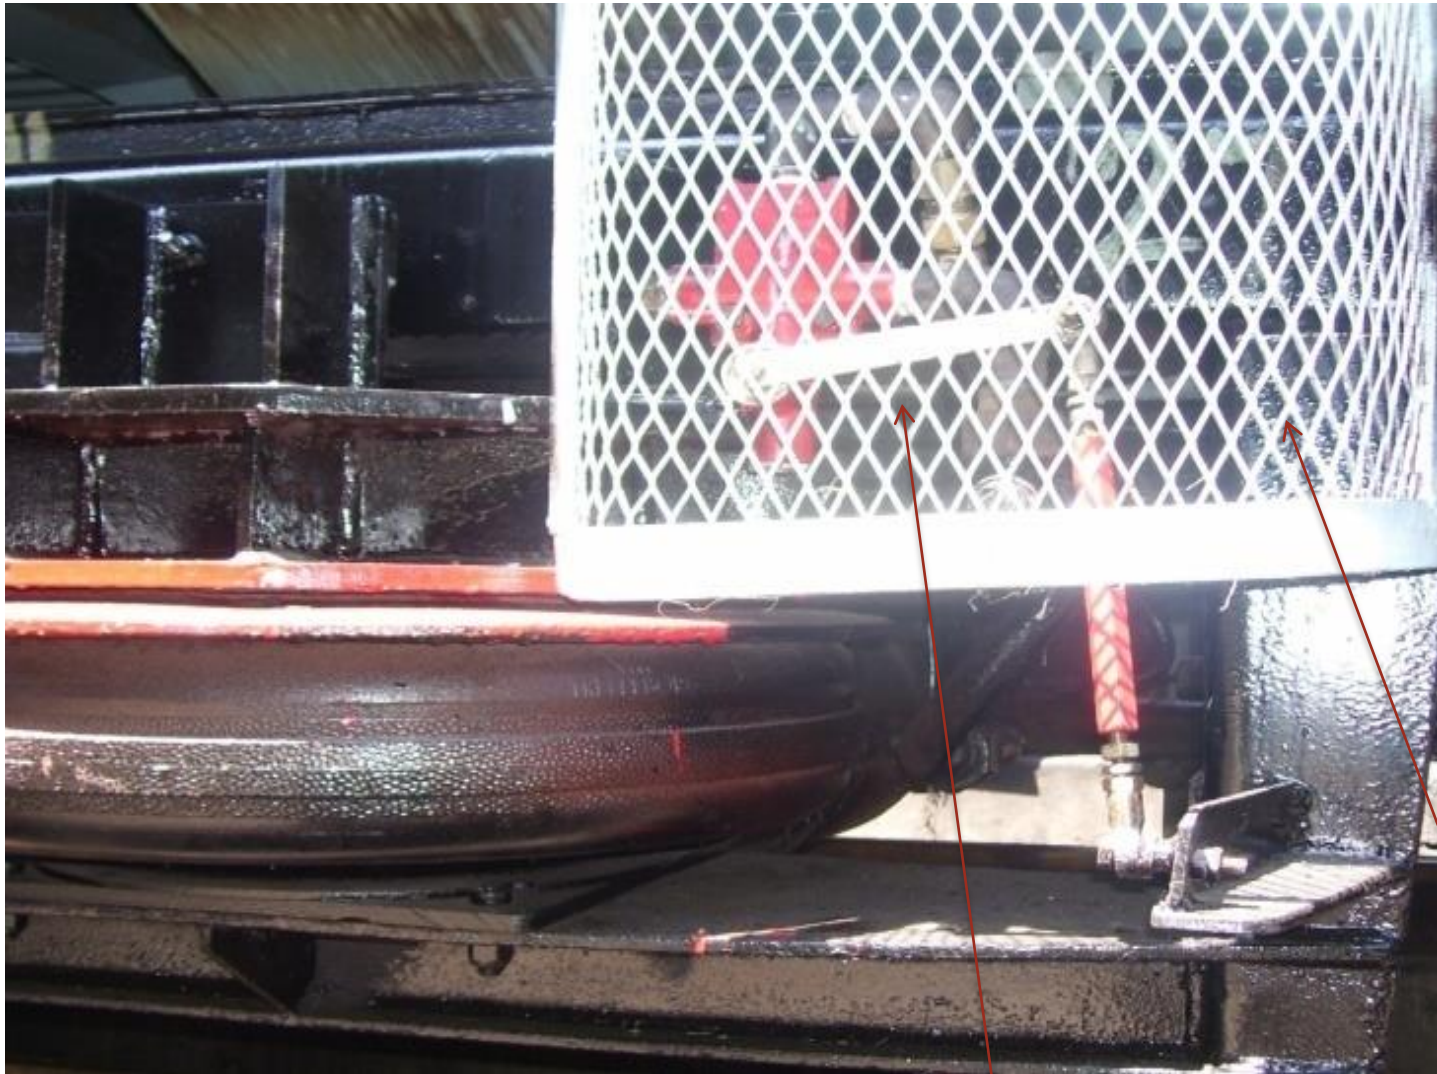
**Protective  
Shield**

**Lever should be in horizontal position**
